## PROJECT PROFILE- Collapsed Well (Surface Casing Primary Structural Support Member)

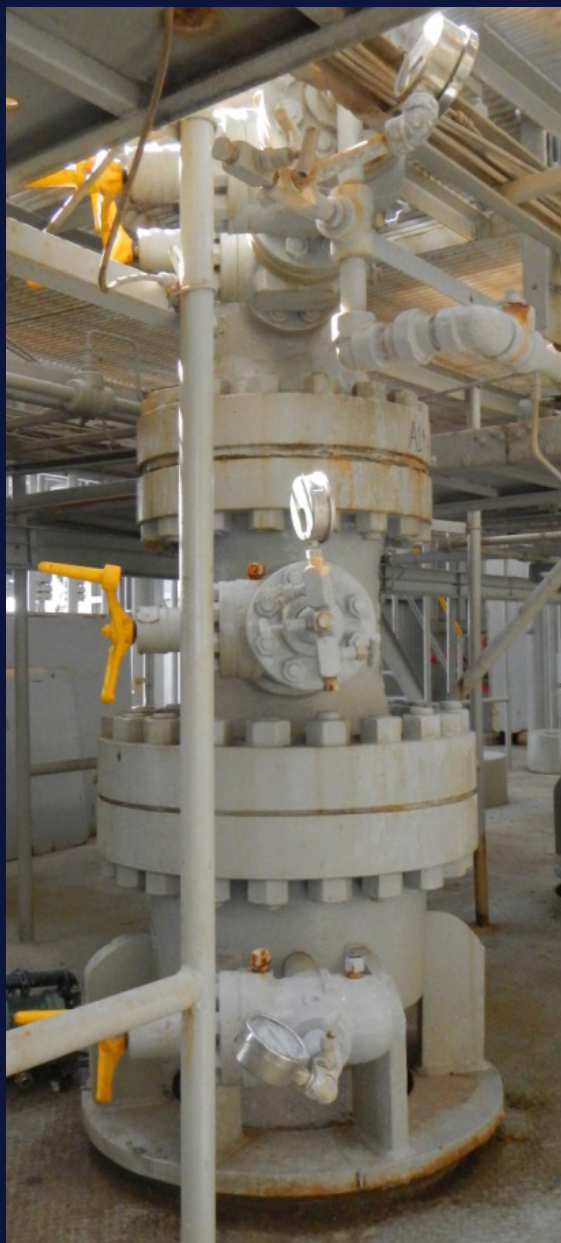
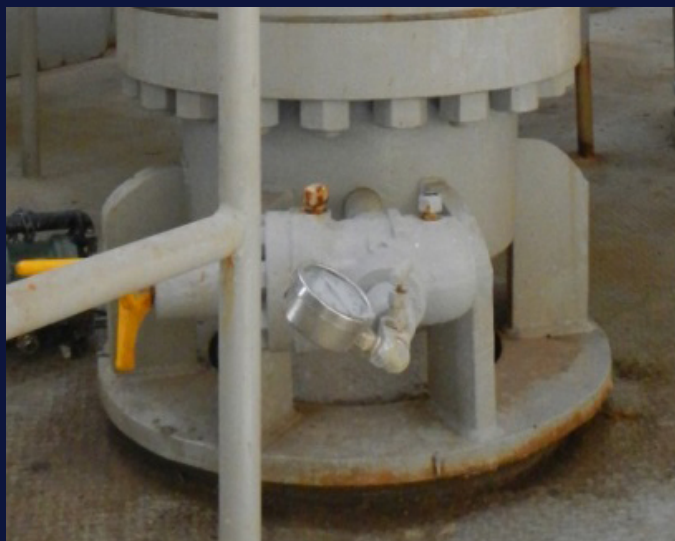
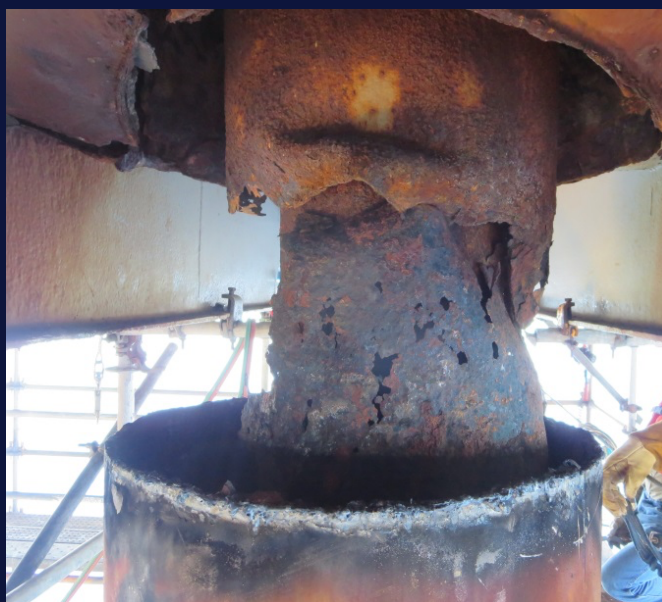
- Routine inspections by the Operator & Regulatory Authorities did not report any issues with this flowing well.
- In subsequent inspections, MADCON technicians discovered subtle, tell-tale signs of a collapsed surface casing.

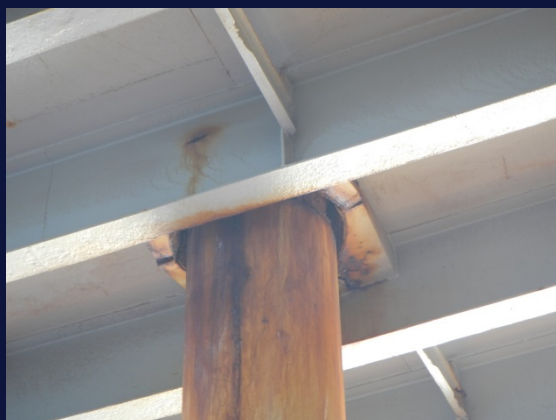
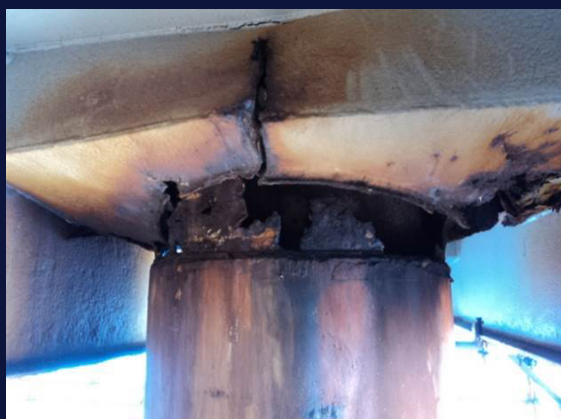
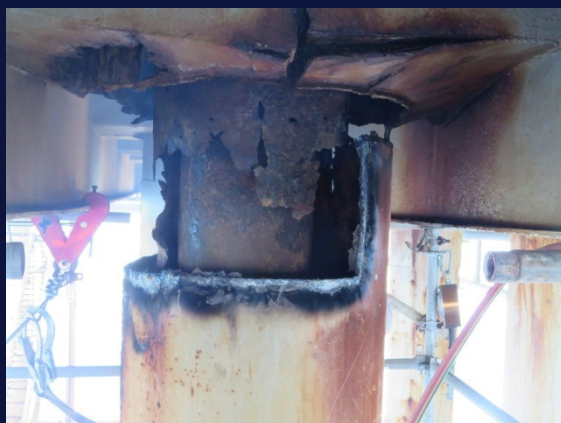
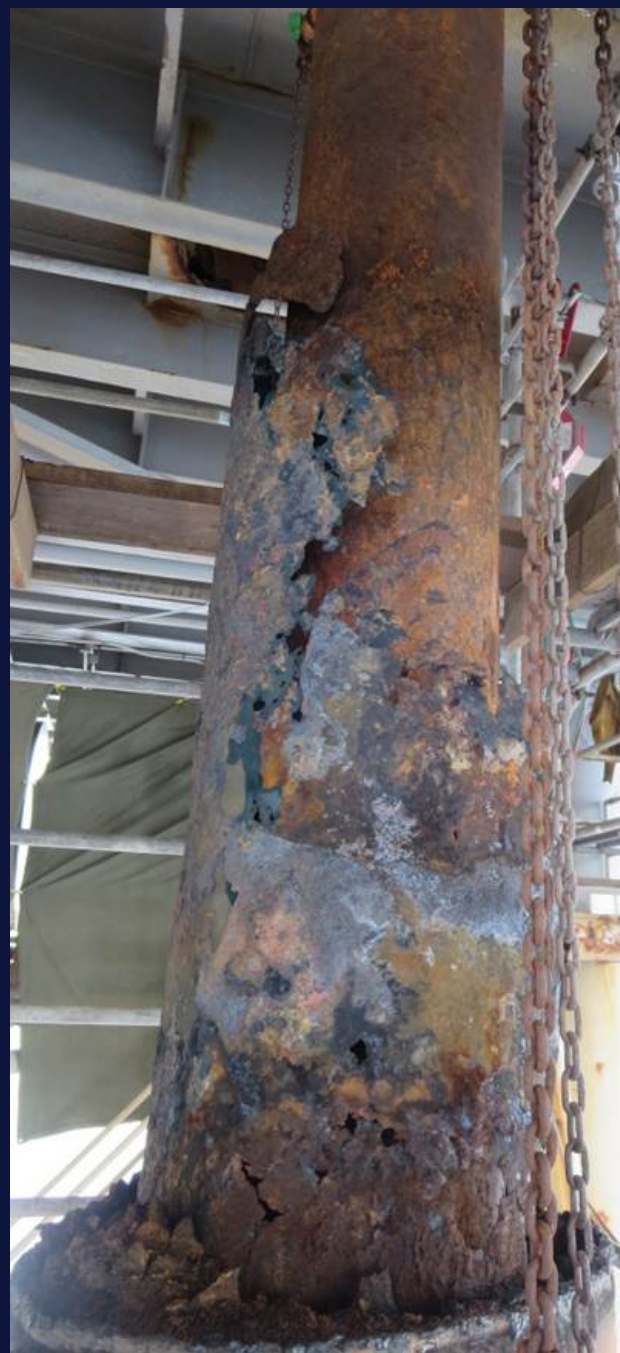
- Well was supported with engineered, rigless design. ( Section of engineered support device can be seen in the top right photo on next slide.)
- Removal of the conductor revealed a totally corroded section of surface casing.

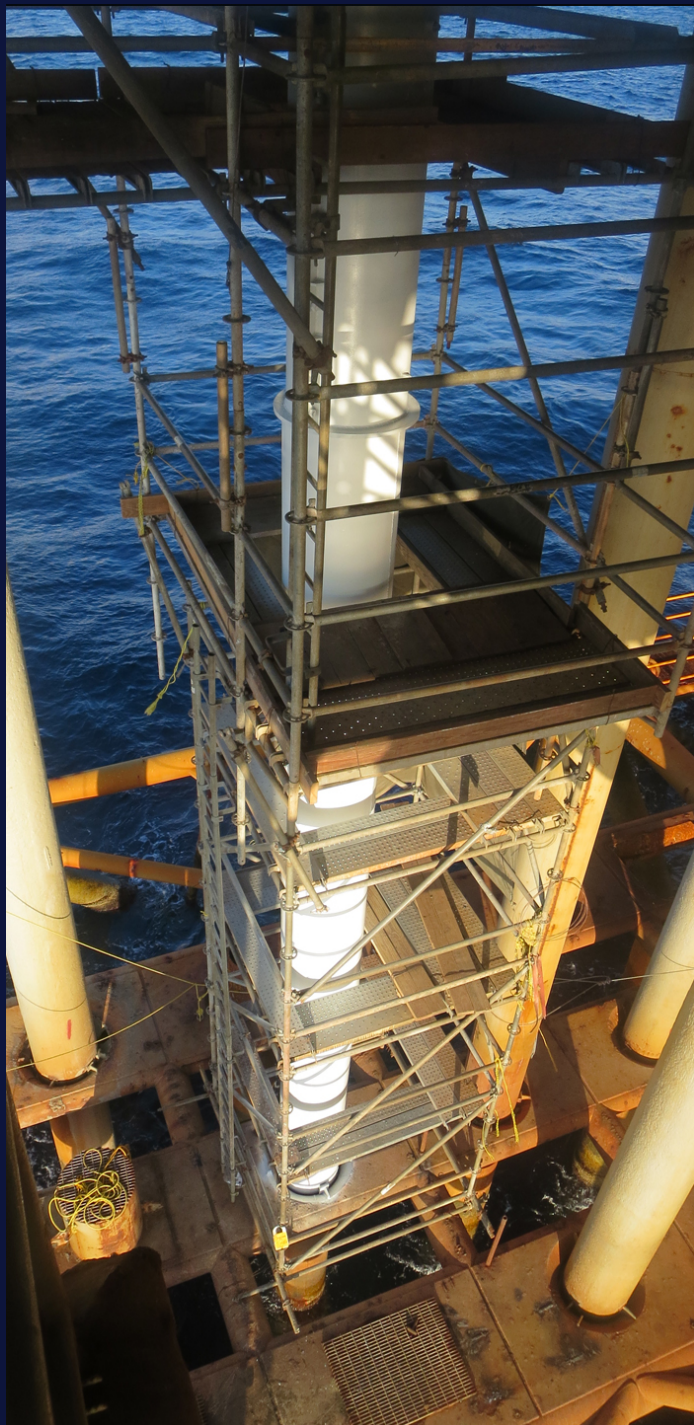
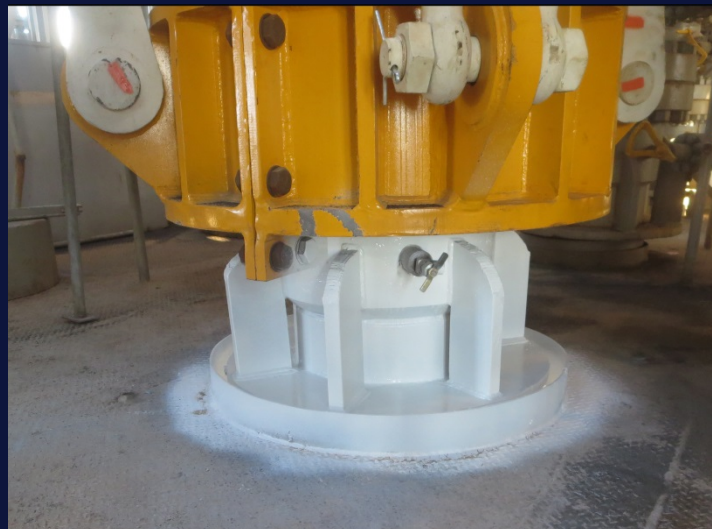
- Surface casing and conductor were restored to full structural integrity and well was brought back to full production utilizing MADCON's patented repair methods.
- With this type well design, the surface casing is the primary structural member supporting the well. The conductor is not designed to carry axial load, but to provide protection for the inner casings from lateral bending moment in heavy wave loads.
- The root cause of the failure of the surface casing was due to the conductor to surface casing annulus being open to atmosphere which allowed active (but hidden) corrosion of the surface casing to the point of collapse.
- Grouting and/or sealing the conductor to surface casing annulus is critical in preventing active corrosion of the surface casing and interior of the conductor.
